**STAFF REPORT 06-26-2019 MEETING**

**APPLICATION NUMBER: 19-6300**

**ADDRESS: 2221 WABASH**

**HISTORIC DISTRICT: CORKTOWN**

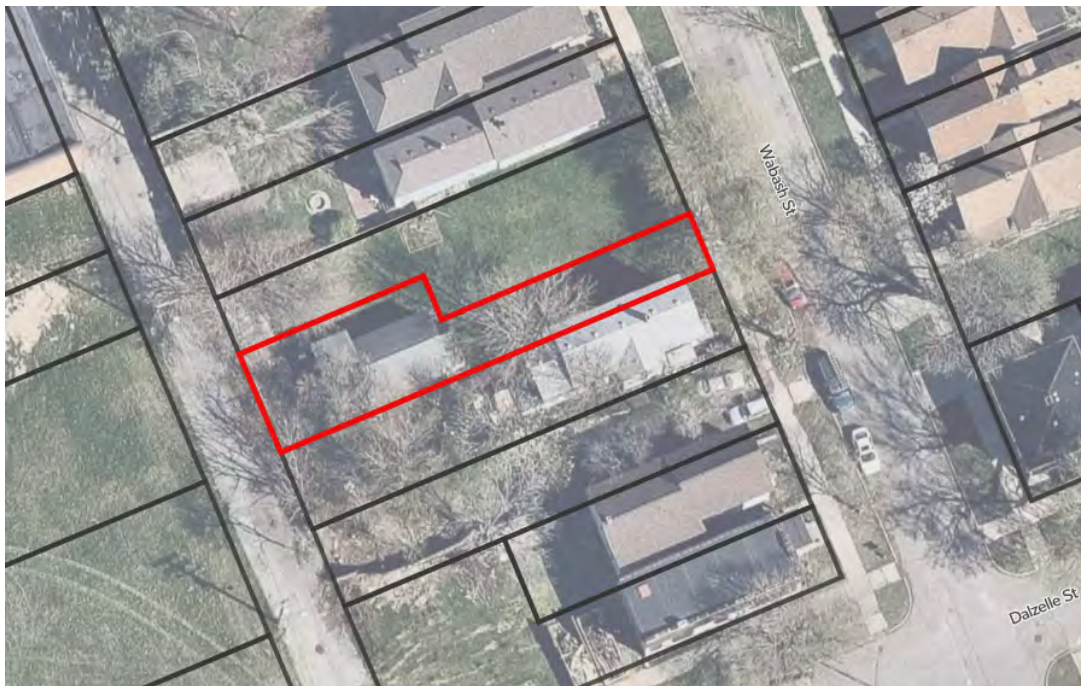
*2221 Wabash, current parcel boundaries per City of Detroit Parcel Viewer.*

In its current configuration, both 2221 and 2225 Wabash appear to be maintained as a single large parcel with no delineation of the boundary between them. 2221 Wabash has a small, late nineteenth century “workers cottage” set back to the extreme rear of the parcel, a setback of more than 80 feet. All of the 2225 Wabash parcel is currently grass turf or planted beds, as is the front (street-adjacent) portion of 2221 Wabash, which measures about 18 feet in width. The property (i.e., both parcels) appear to be well-maintained and 2221 Wabash appears to be occupied and in fair to good condition.

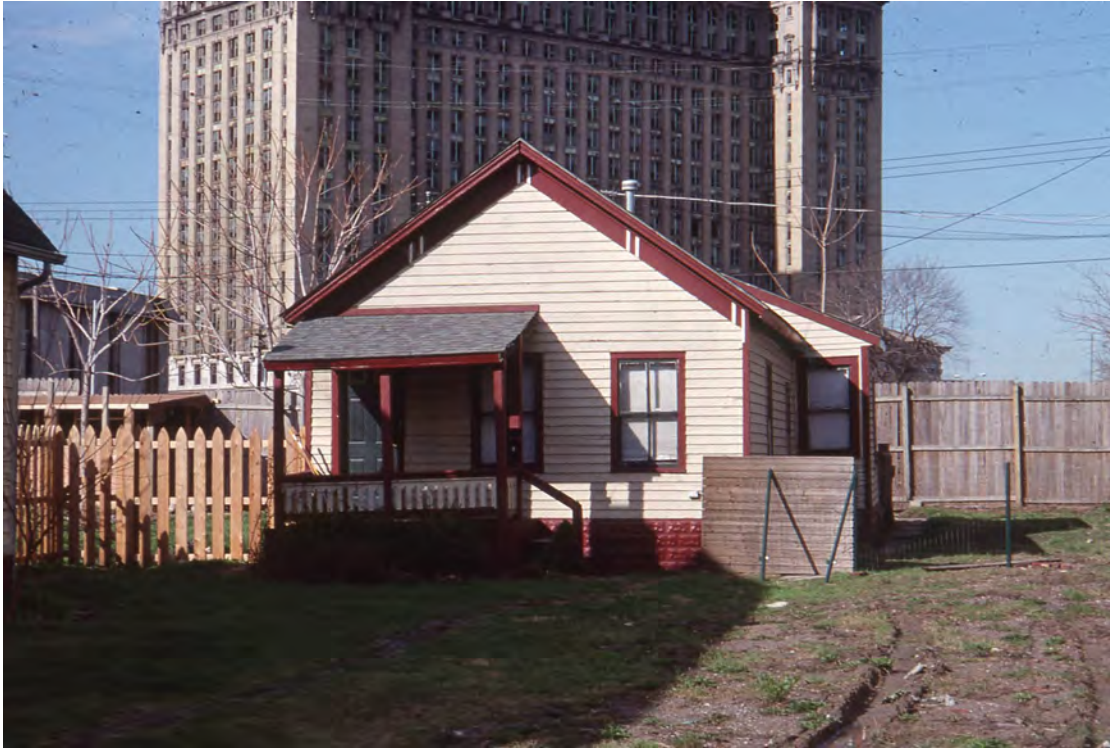
*2221 Wabash, HDAB Designation Slide, circa March 1985.*

Based on the designation slide, most of the current porch detailing is not original. Two turned wood columns have replaced three simple square posts, and the porch balustrade does not match the earlier flat-sawn configuration. Some apparently original 2/2 wooden windows have been replaced with 1/1 vinyl. With the exception of its clapboard siding and wood trim, the house has lost much of the historic integrity it had when the district was designated.

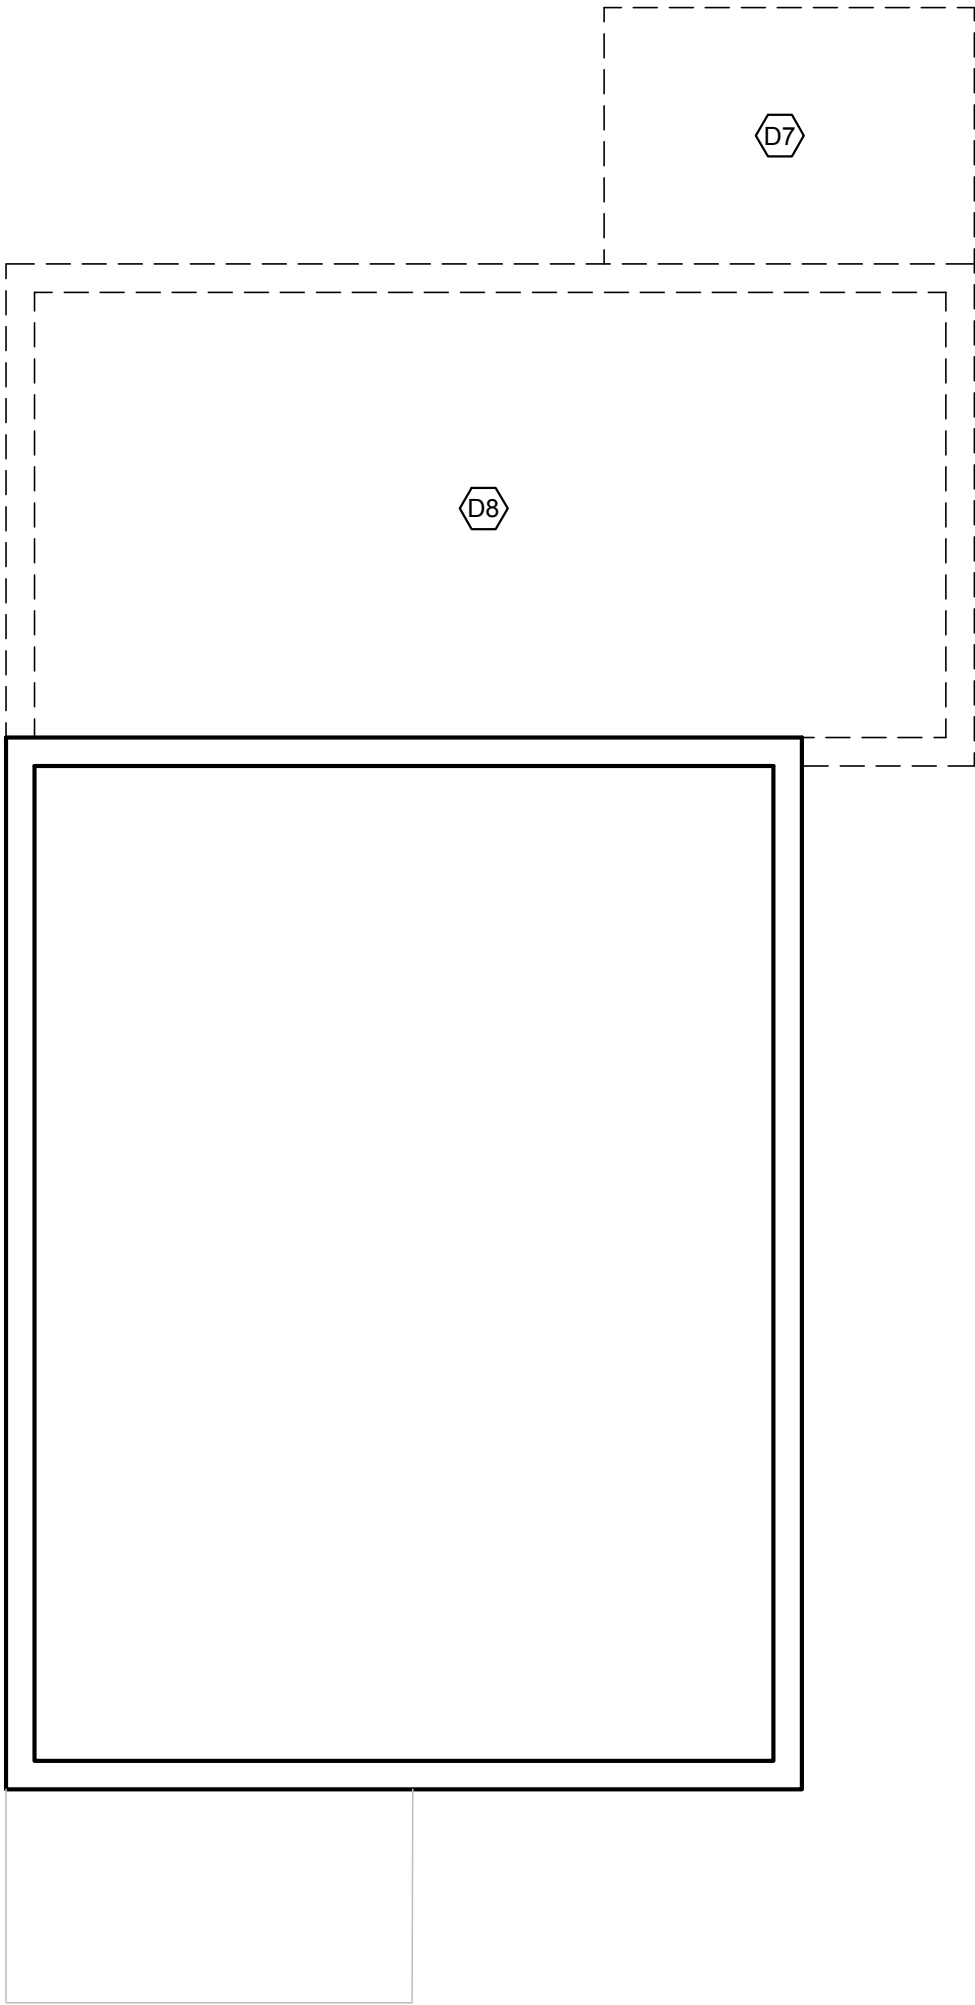
DEMOLITION FOUNDATION PLAN  
SCALE: 1/4"=1'-0"

- Demolish existing rear addition complete; including foundations (original structure to remain)
- Remove existing fence and site debris
- Remove existing rear deck and concrete pads in rear of property

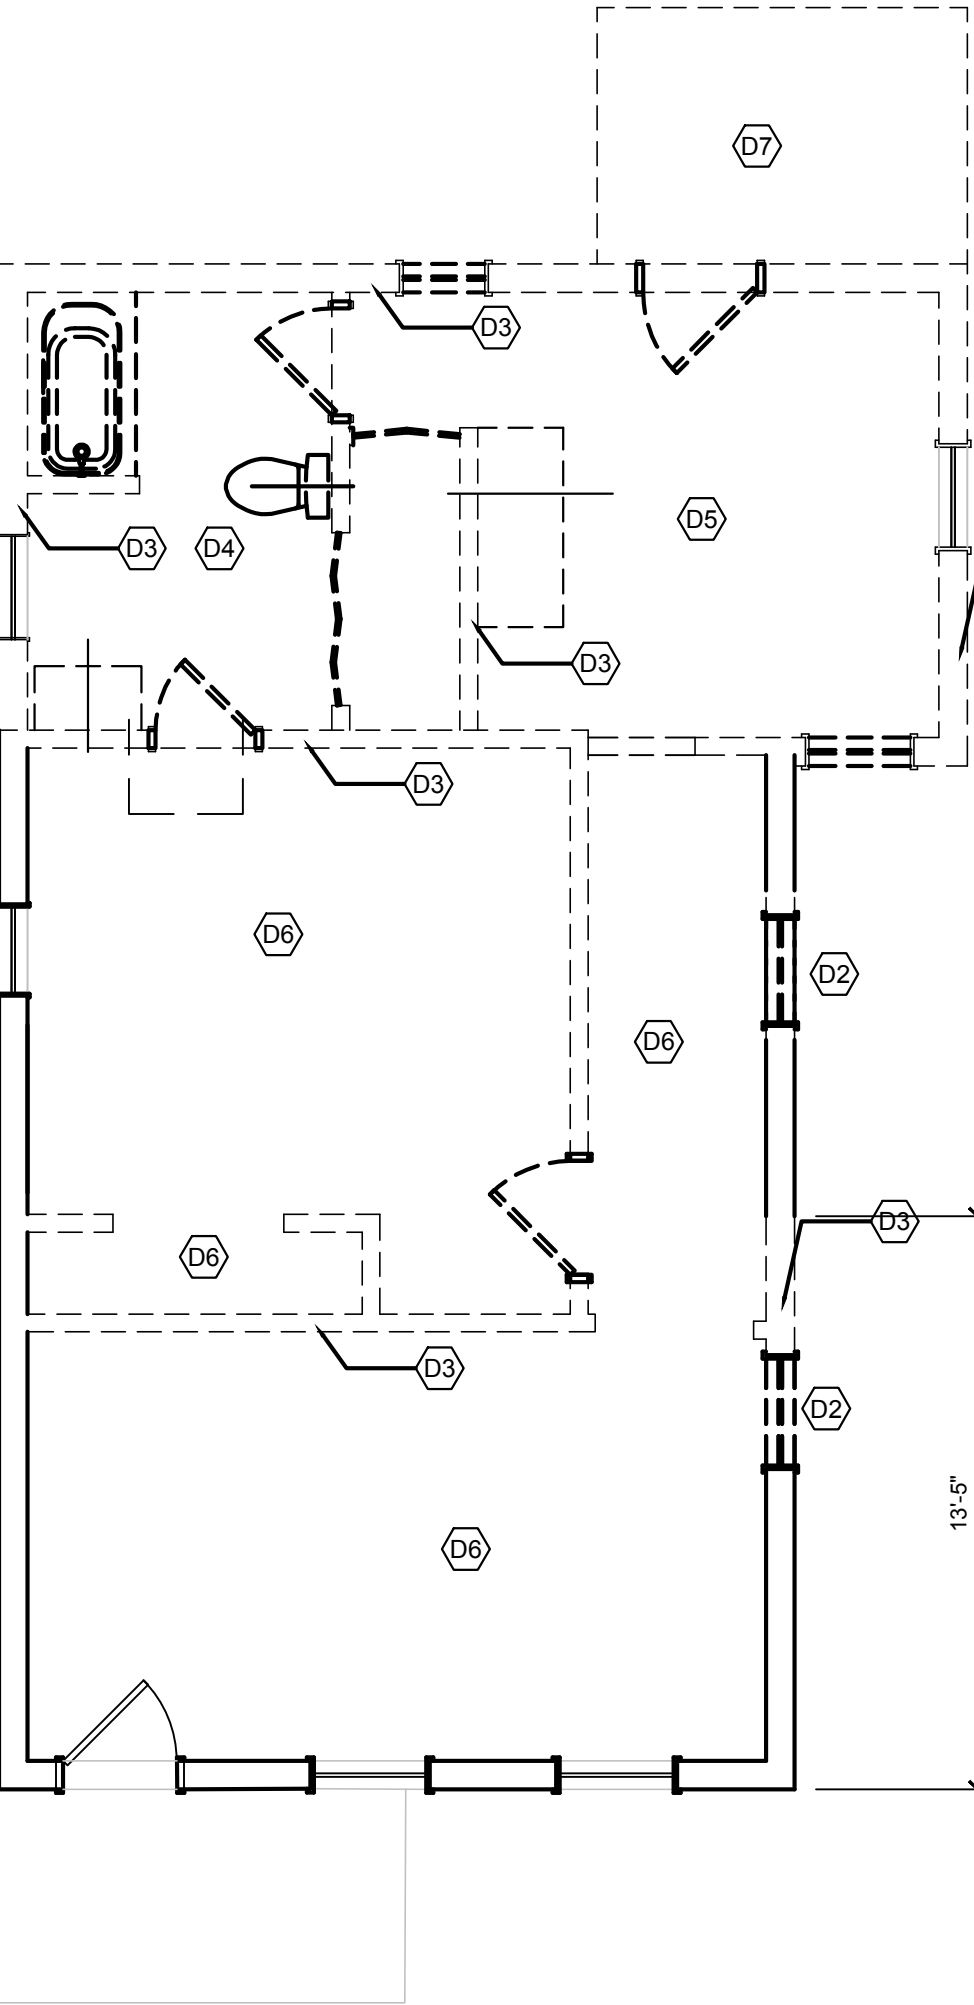
DEMOLITION FLOOR PLAN  
SCALE: 1/4"=1'-0"

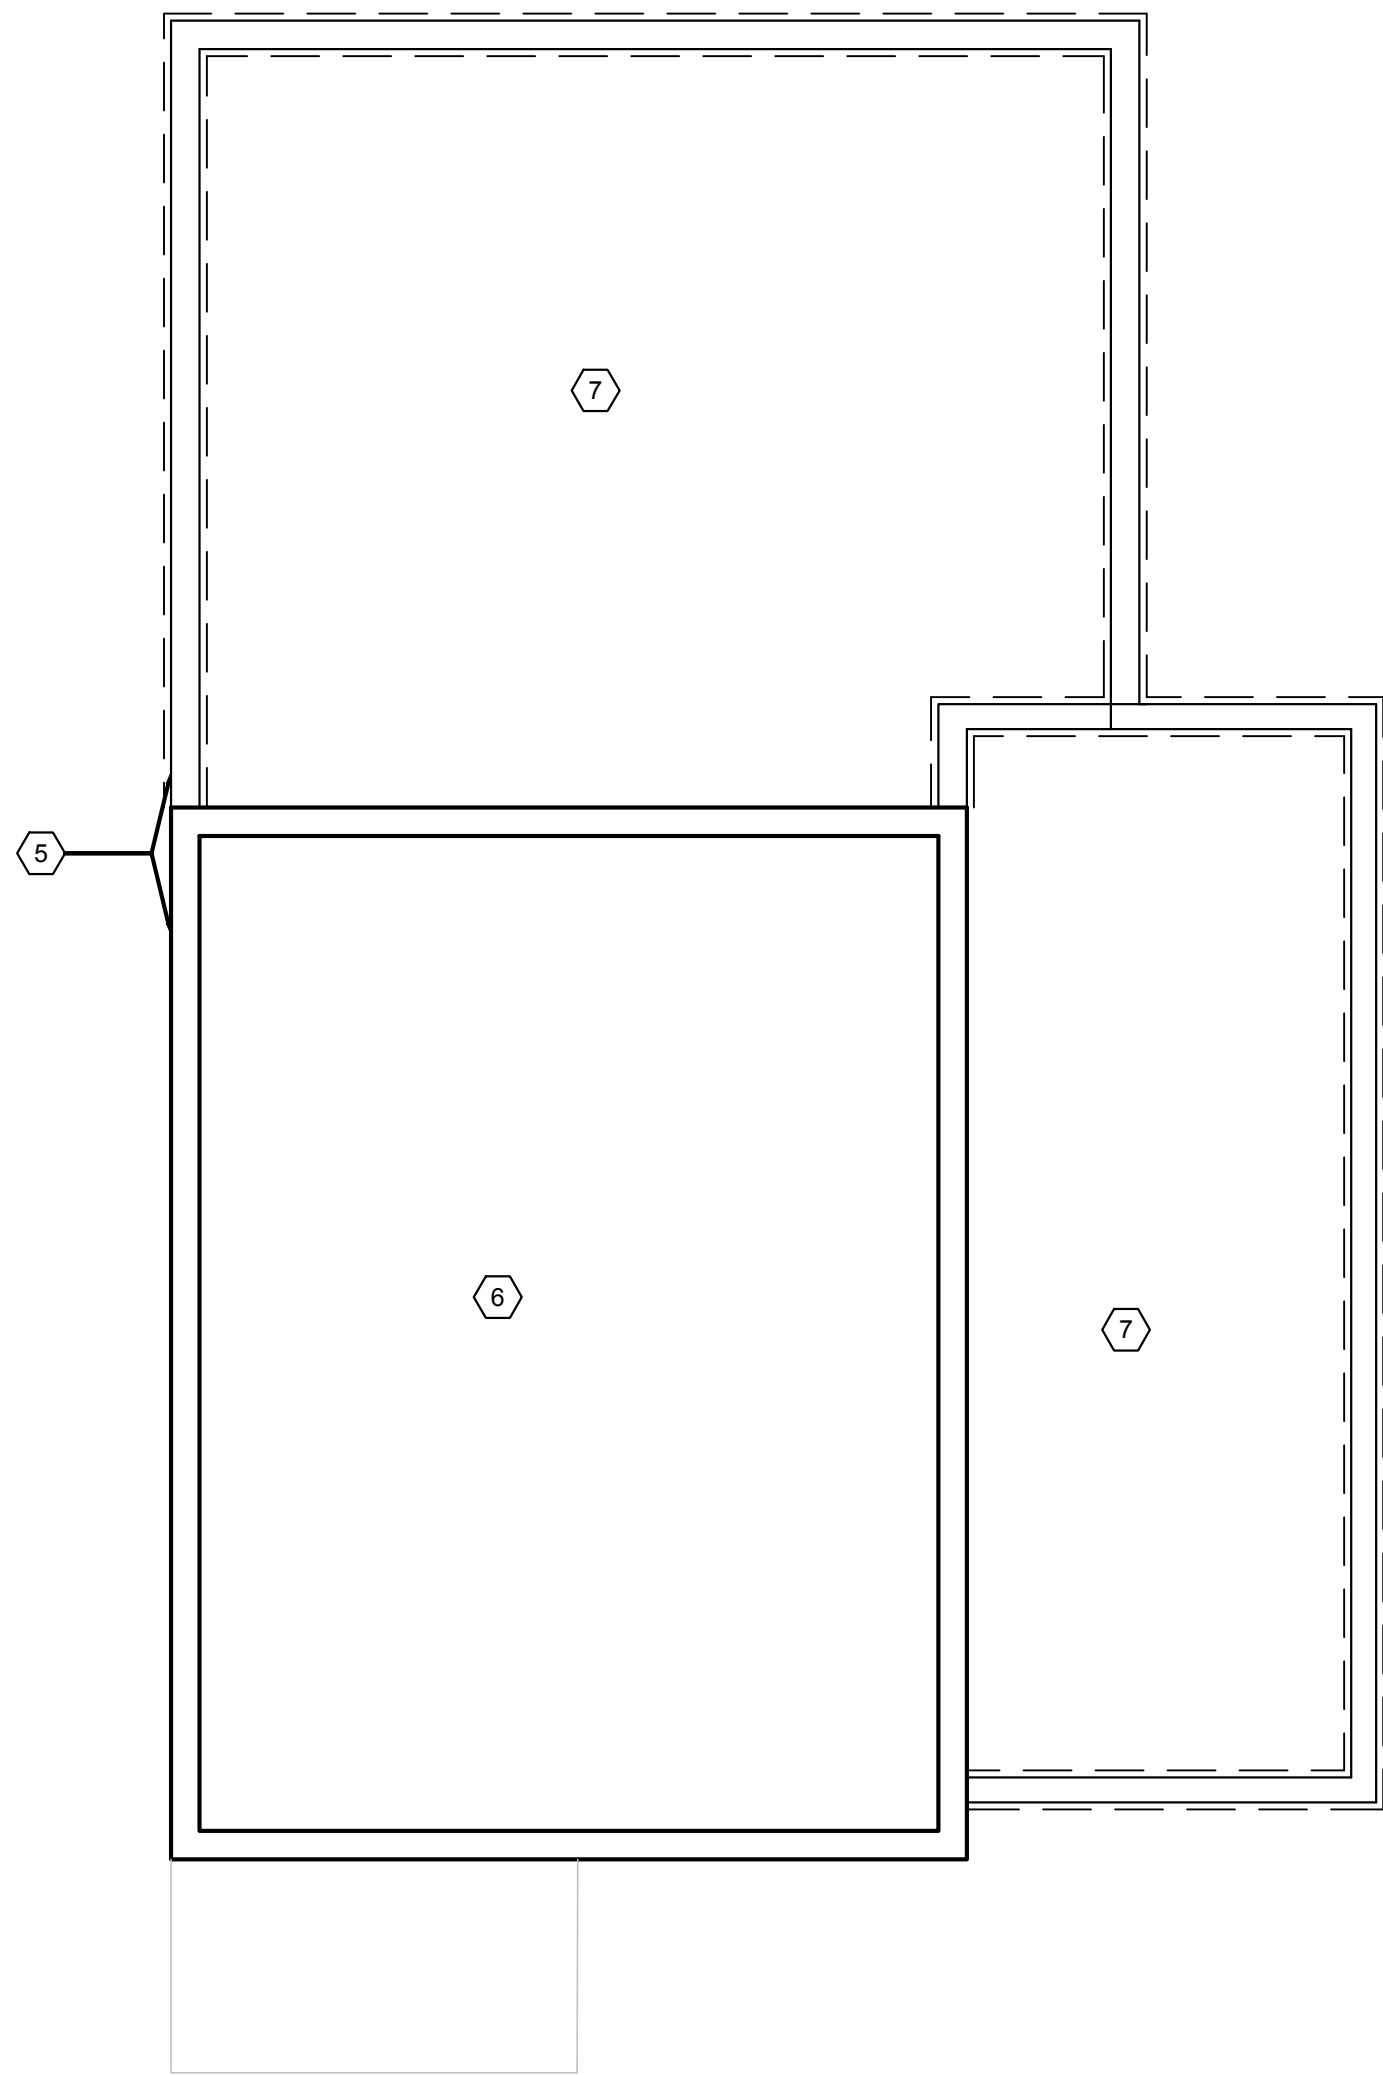
FOUNDATION PLAN  
SCALE: 1/4"=1'-0"

- 1 STACKED WASHER AND DRYER
- 2 FURNACE AND ON-DEMAND HW SYSTEM
- 3 EXISTING WINDOWS TO REMAIN
- 4 FRONT PORCH TO REMAIN
- 5 ALIGN ADDITION WITH FACE OF EXISTING
- 6 EXISTING FOUNDATION TO REMAIN
- 7 NEW FOUNDATION WITH CRAWL SPACE

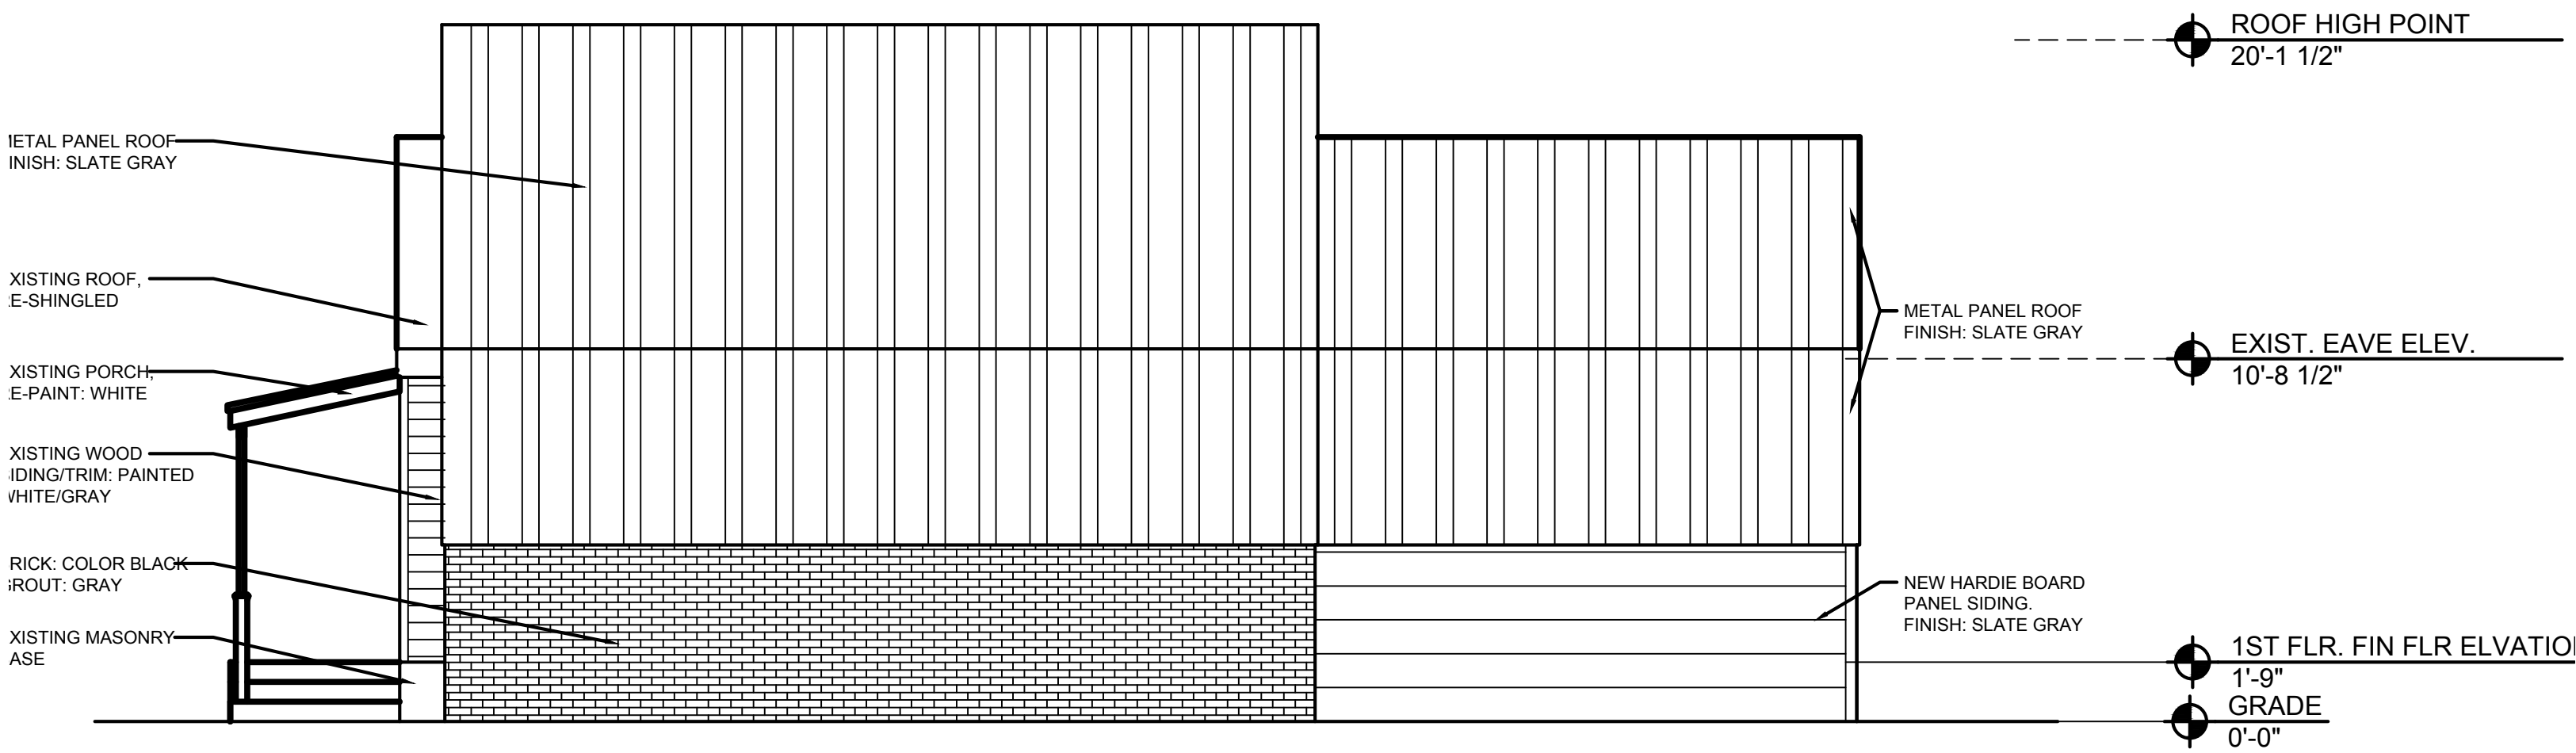
3 NORTH ELEVATION  
A1.1 SCALE: 1/4" = 1'-0"

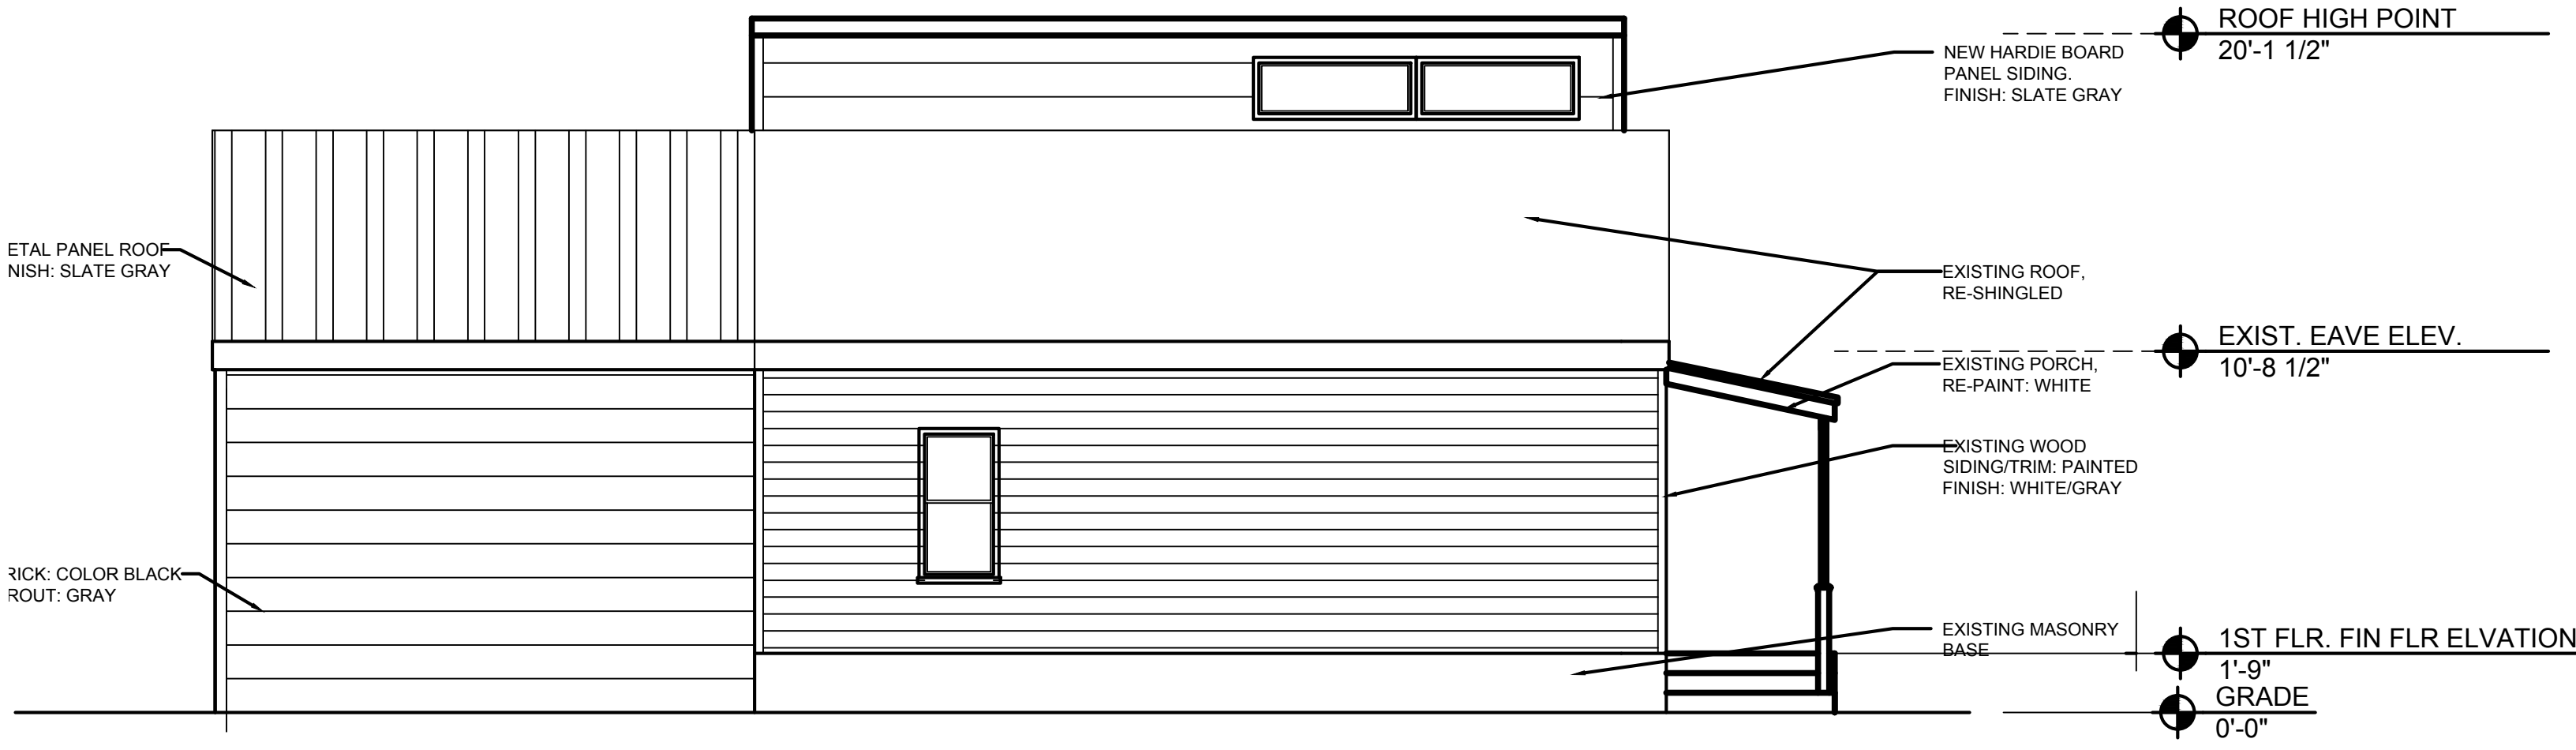
4 SOUTH ELEVATION  
A1.1 SCALE: 1/4" = 1'-0"

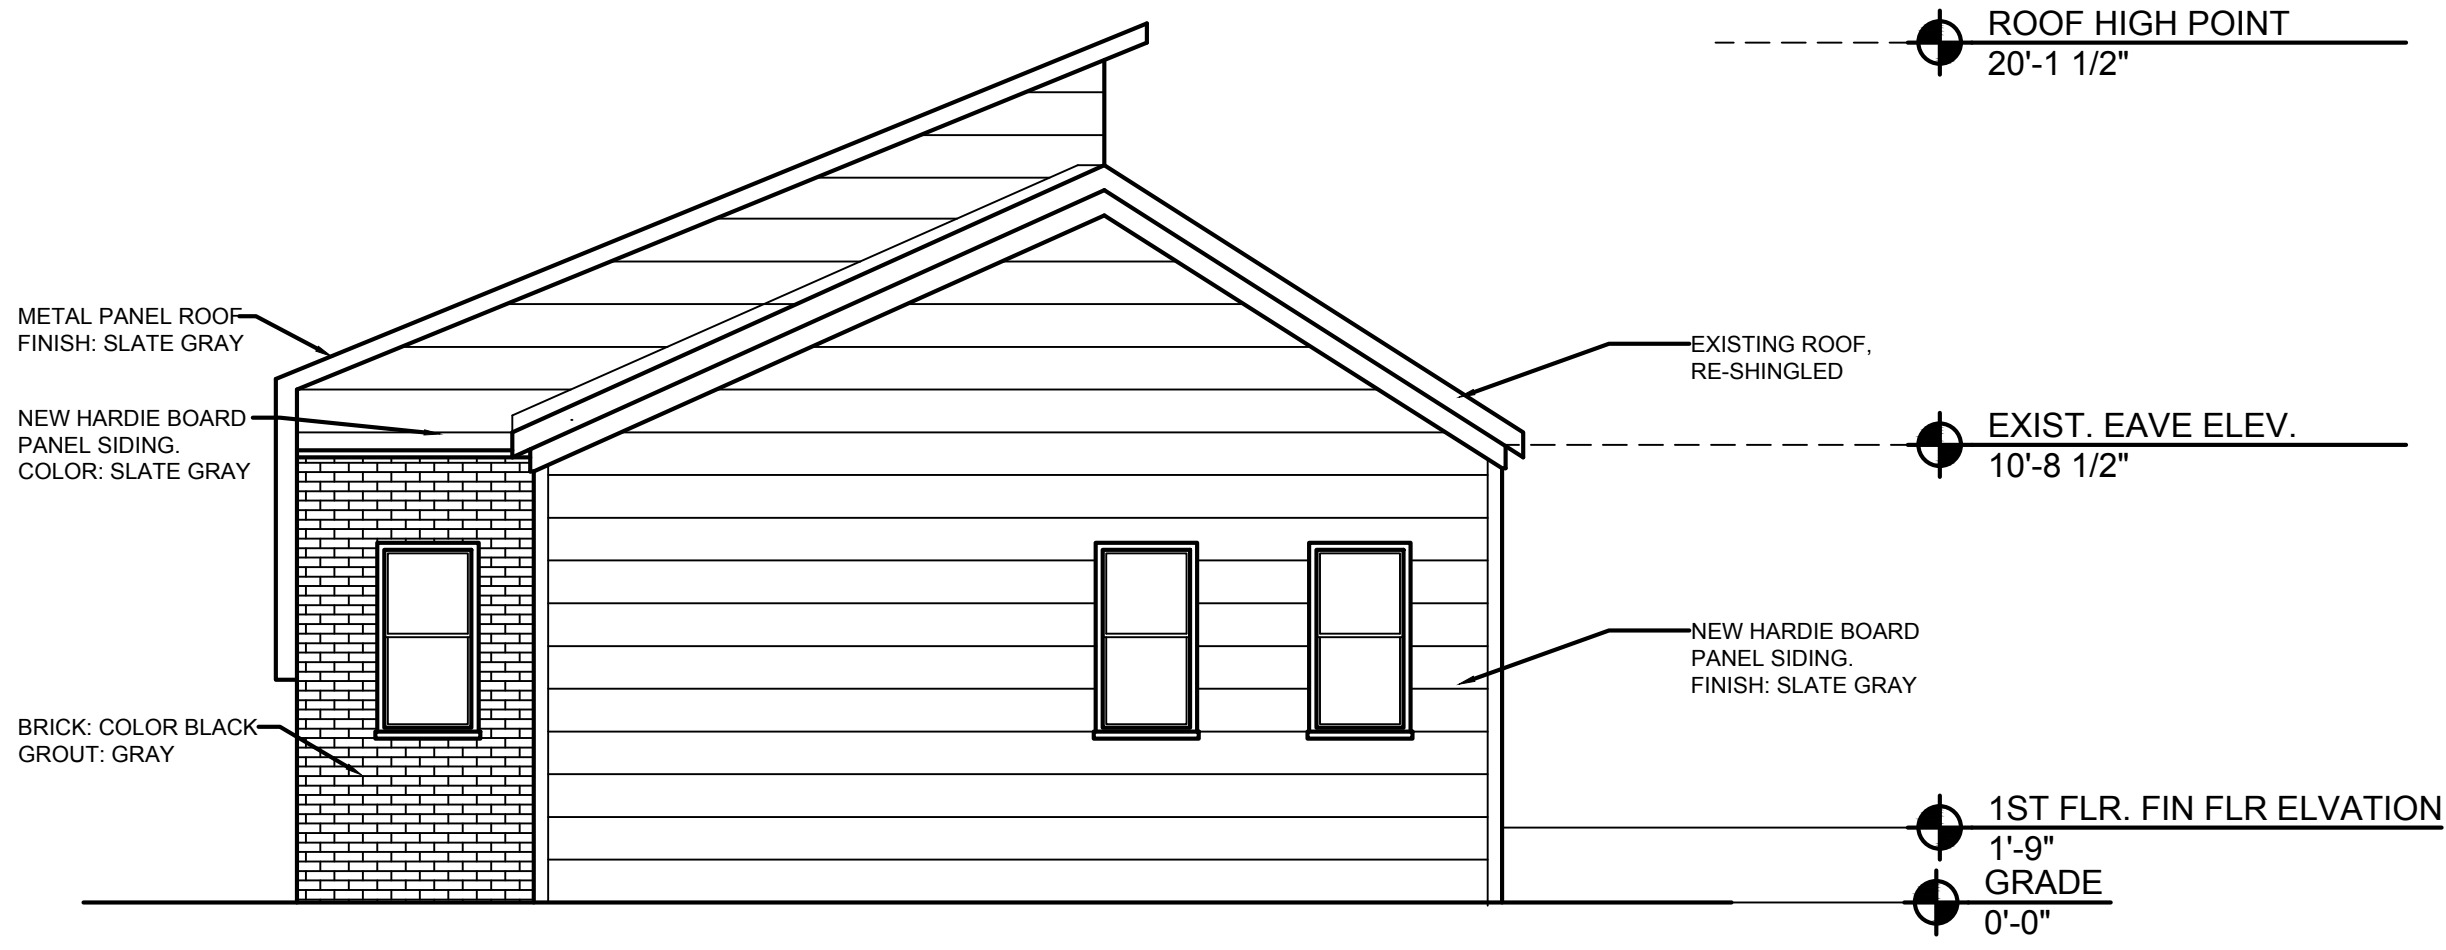
2 WEST ELEVATION  
A1.1 SCALE: 1/4" = 1'-0"

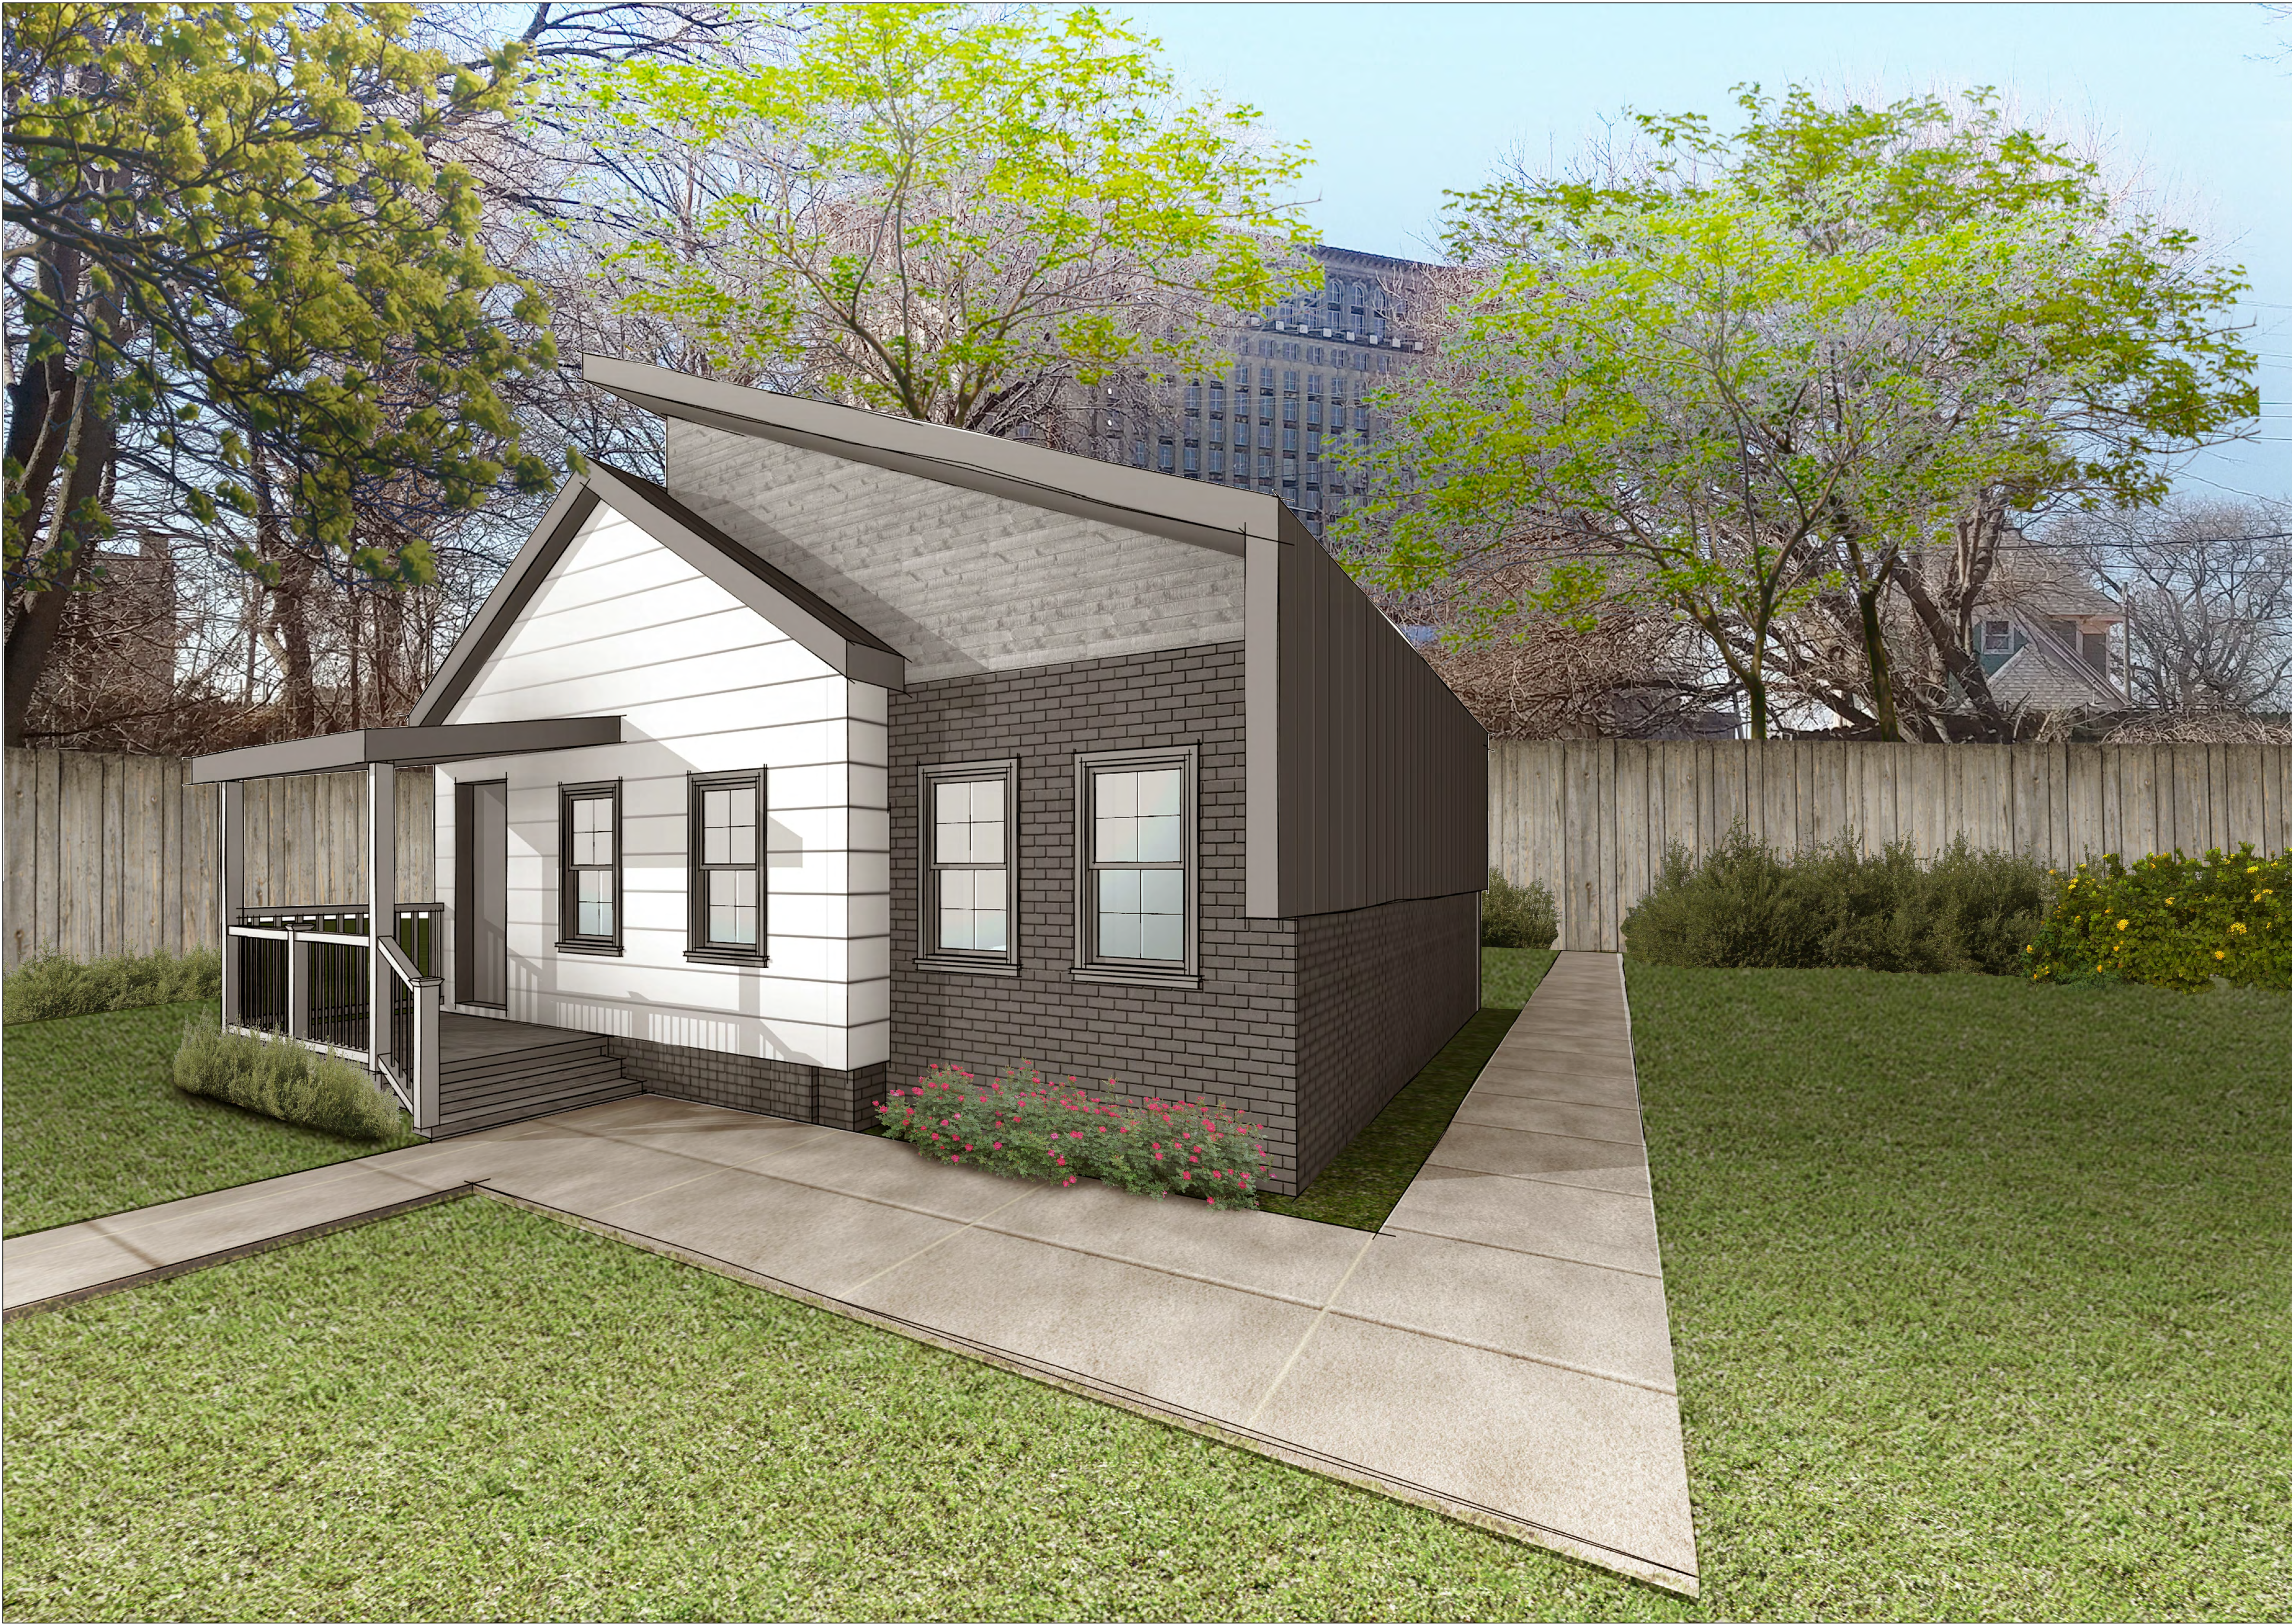
2 WEST ELEVATION  
A1.1 SCALE: 1/4" = 1'-0"
